Surface Cracking at the Rolling Mill

THE PROJECT

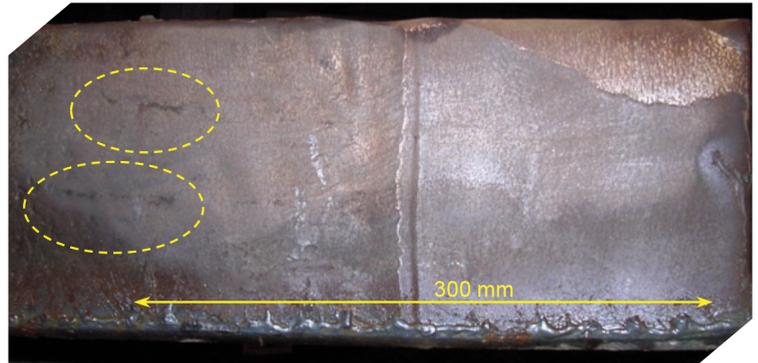
On-site investigations quickly identified that the cracking was originating in the feedstock. Figure 1 shows an example of the cracks found in the cast slab.

Samples of slab were selected for investigation by optical microscopy and mathematical modelling of the casting process was carried out. It was found that due to incorrect water cooling on the slab caster, specific locations of the slab surface were undergoing multiple metallurgical transformations that were causing localised stresses to result in surface cracking.

Surface cracking found on feedstock slab

The suggested recommendations were followed and slabs were subsequently cast with no cracks. The saving in being able to minimise scrap on this product was £120,000 per annum.

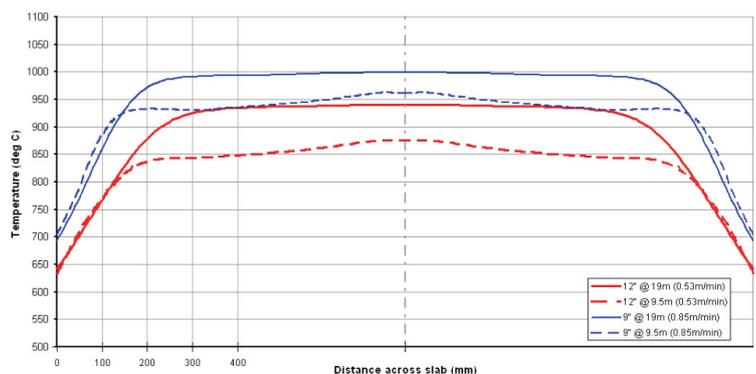
Mathematical model results showing temperature across the slab width
