Heat Exchanger Tube Failure

THE PROJECT

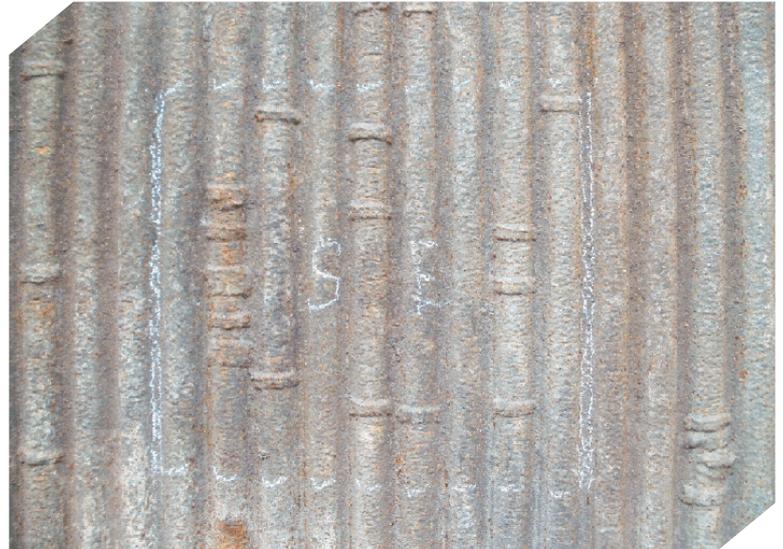
The heat exchanger was designed for an operational life of 15 months, but due to increasing numbers of leaks it was taken out of service after 12 months. Reduced lifespan of the heat exchangers was noted on successive occasions. Water leaks led to downtime for weld repairs and excessive water leakage at this location was a safety concern.

Section of heat exchanger with multiple weld repairs on some tubes

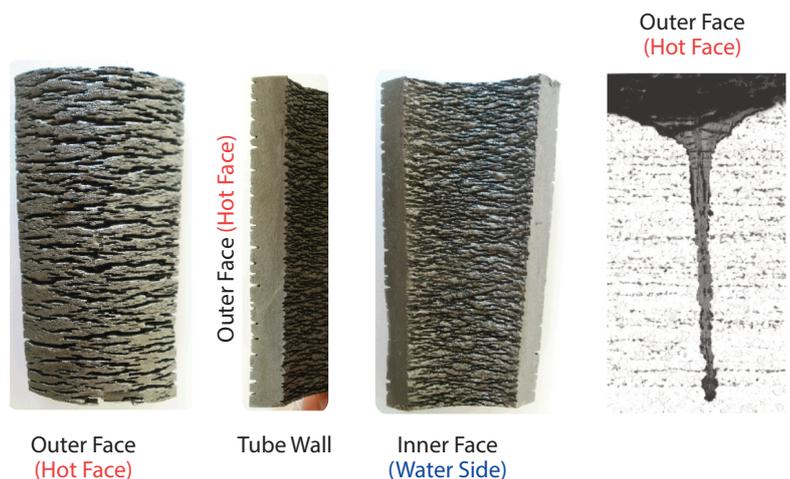
On-site inspections were carried out followed by sampling. From optical and electron microscopy analysis it was found that the whole of the heat exchanger tube work was suffering from severe cracking.

It was determined that the leaks were occurring by corrosion fatigue cracking. The mechanism was symptomatic of the plant operating method and necessitated a redesign to give future viability to the operations. This was done and in the three years of operation water leaks have not been a problem.

Sample of tube with surface cracks plus cross sectional microstructure
